## *Imagery Analysis Report*

Solid Rocket Motor Test Facilities,  
Leningrad, USSR

## SOLID ROCKET MOTOR TEST FACILITIES, LENINGRAD, USSR

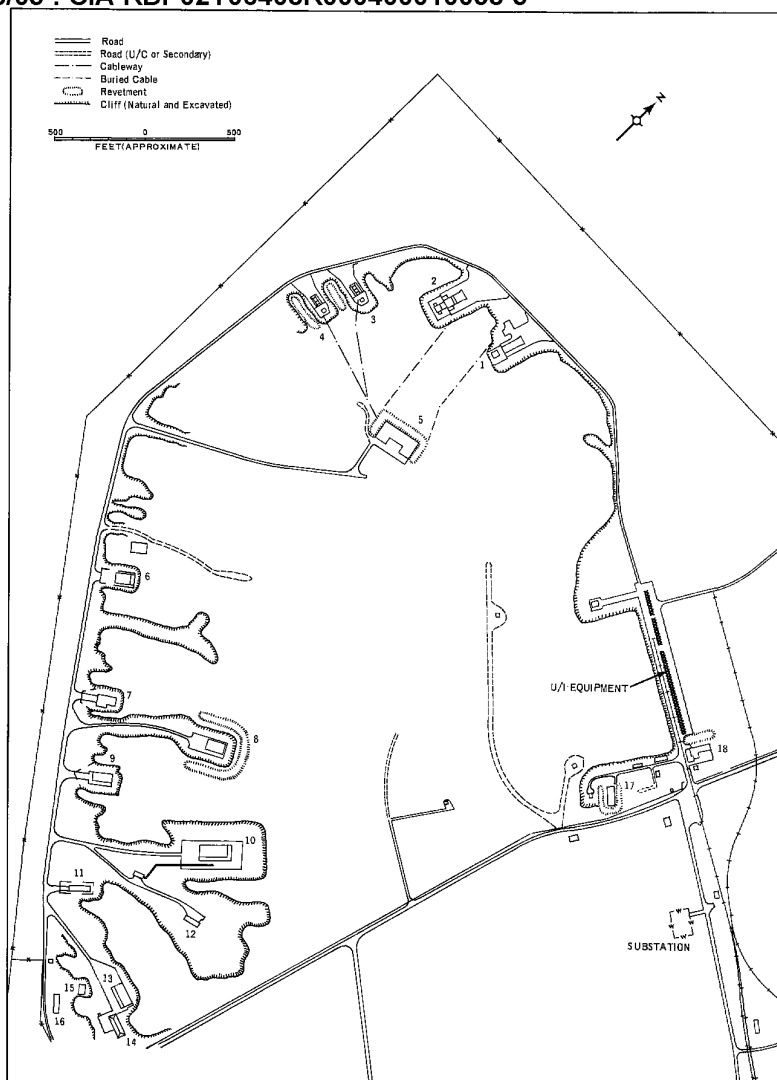
The Leningrad Solid Rocket Motor Test Facility 1 (Figure 2) is located five nm northeast of Leningrad at 60-03N 30-36E. It consists of three sections: a test section, a rail-served materials handling section, and a support and possible vibration/structural testing section. A rail spur from the facility joins the main rail line about one mile from the Chemical Combine, Okhtenskiy in northeastern Leningrad, and another spur leads from this point to the Petrokrepost Probable Rocket Motor Plant, Morozov, approximately 14 nm to the east. Structures within the facility are shown in Figure 2; their function/description and dimensions are given in Table I.

The test section contains four, earth-barricaded, horizontal test cells which fire directly across the access road serving them. There are the large Test Cells 1 and 2 and the medium-size Test Cells 3 and 4.

Test Cells 1 and 2 are located approximately 330 feet apart, and 660 and 700 feet respectively from the earth-mounded instrumentation control building (Item 5). Test Cell 1 appears to be slightly longer than Test Cell 2. Dimensional details of Test Cell 2 are shown in Figure 3. The overall dimensions of Test Cells 1 and 2 are approximately 135 by 60 feet and 120 by 60 feet, respectively, each with a firing bay approximately 40 feet in width.

Vibration/structural testing of rocket motors and general support is probably done in the eleven buildings (Items 6-16) on the southwestern side of the test facility.

Seven of the buildings (Items 6-10, 12 and 13) are located in earthen barricades excavated from the natural gullies of the hillside. This indicates that these buildings are used for either storage or hazardous operations involving rocket motors. Vibration and structural tests could possibly be accomplished in the larger high-bay buildings (Items 8 and 10). The smaller low-bay buildings (Items 6 and 7) and the small high-bay buildings (Items

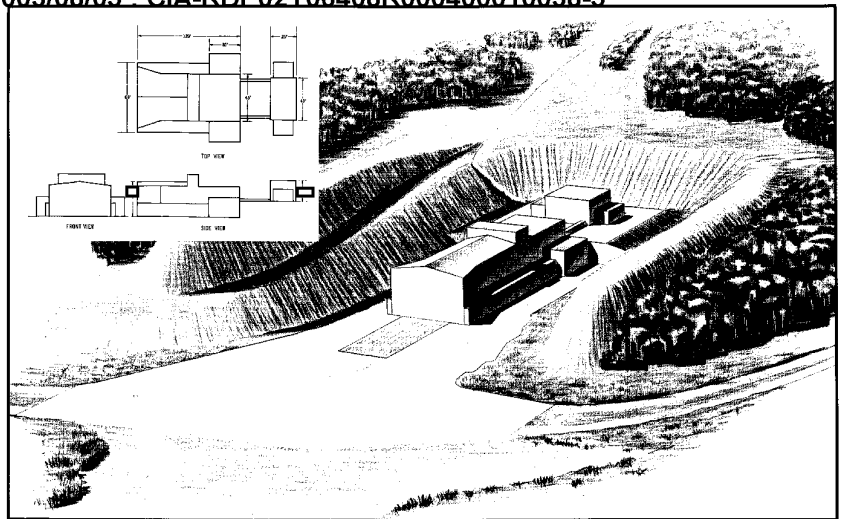
FIGURE 3. CONCEPT OF TEST CELL 2, TEST FACILITY No. 1

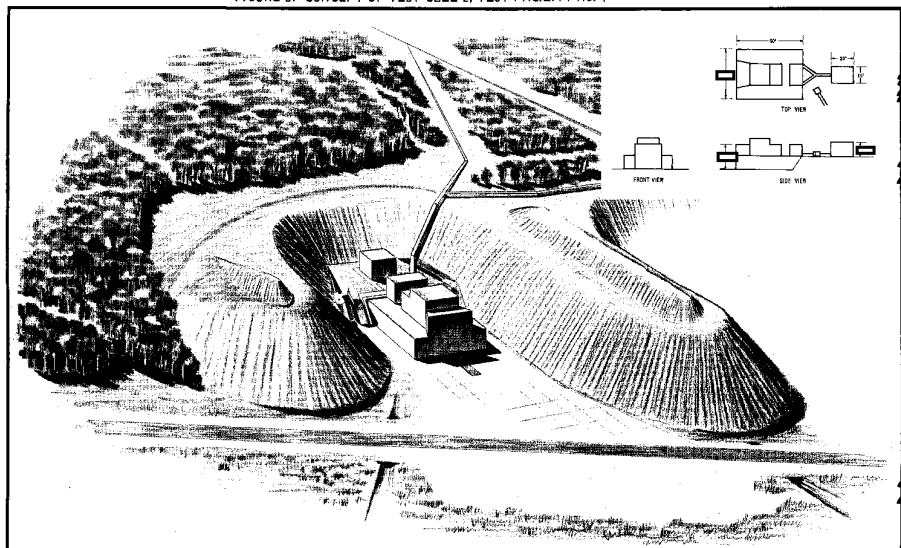
FIGURE 4. CONCEPT OF TEST CELL 3, TEST FACILITY No. 1

Test Cells 3 and 4, about 180 feet apart, are identical, earth-barricaded structures measuring approximately [REDACTED]. Details of Test Cell 3 are shown in Figure 4.

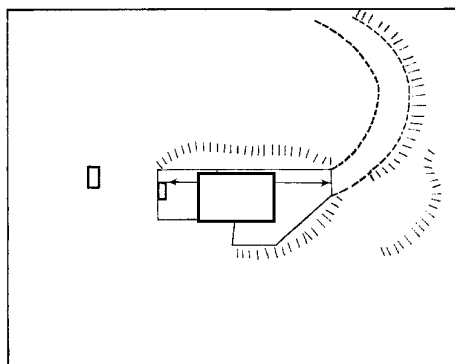
FIGURE 6. TEST POSITION 1, TEST FACILITY No. 2

Test Position 1 (Figure 6) is the largest and most elaborate position at the facility. It consists of a concrete apron, measuring approximately [redacted] located within an earthen barricade formed by excavating a natural gully.

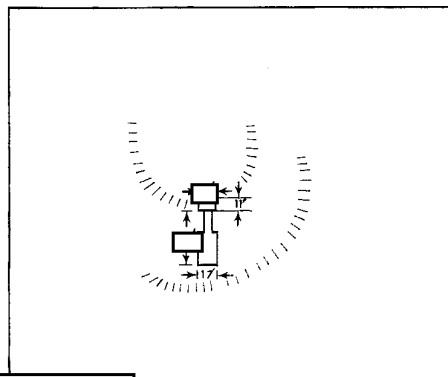
FIGURE 7. TEST POSITION 5, TEST FACILITY No. 2

Test Position 5 (Figure 7) is located at the south-east end of the clearing. The position consists of a small concrete blast apron measuring approximately [redacted] located on a ledge just below the edge of the cliff.

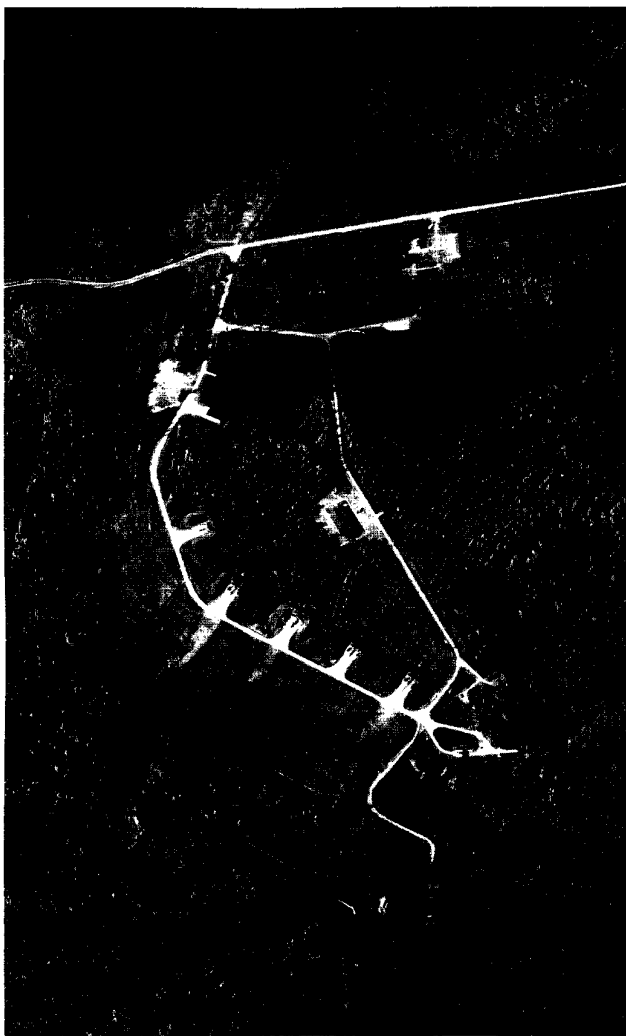
FIGURE 8. Leningrad Solid Motor Test Facility No. 3

The Solid Rocket Motor Test Facility 3 (Figure 8) is located at 60-15N 30-44E, 18 nm northeast of Leningrad and three nm northeast of Solid Rocket Motor Test Facility 2.

It contains six horizontal test positions (Figure 8, Items 1-6), a suspect subsurface vertical test position (Item 7), an earth-mounded control building (Item 8), an earth-barricaded possible vibration/structural test building (Item 9), and an earth-mounded possible storage building (Item 10). Three other buildings (Items 11-13) are located immediately outside the fence and probably house the administrative/engineering and support elements for the facility. Structures within the facility are shown on Figure 8; their function/description and dimensions are given in Table III.

Five of the horizontal test positions (Items 1-5) have the same basic configuration of a concrete pad, measuring about [redacted] enclosed by a U-shaped earthen barricade. The spacing between the positions is about the same. In the northwest corner of each pad is a building which is probably connected to a passageway extending through the rear of the barricade. Above-ground instrumentation lines lead from each passageway to the control/instrumentation building, which is 575 feet to the rear of the nearest test position (Item 3).

The control/instrumentation building (Item 8) is located in the central part of the facility. This earth-mounded building measures approximately [redacted]. Above ground instrumentation lines lead from the east side of the building to the rocket motor test positions.

An earthen-barricaded possible vibration/structural test building (Item 9) is located approximately 750 feet west of the control/instrumentation building and 650 feet northwest of Test Position 1. The building measures approximately [redacted] feet with a high bay section measuring approximately [redacted] feet in height. The massive earthen barricade and the distance from other structures indicate hazardous operations involving large quantities of explosive material.

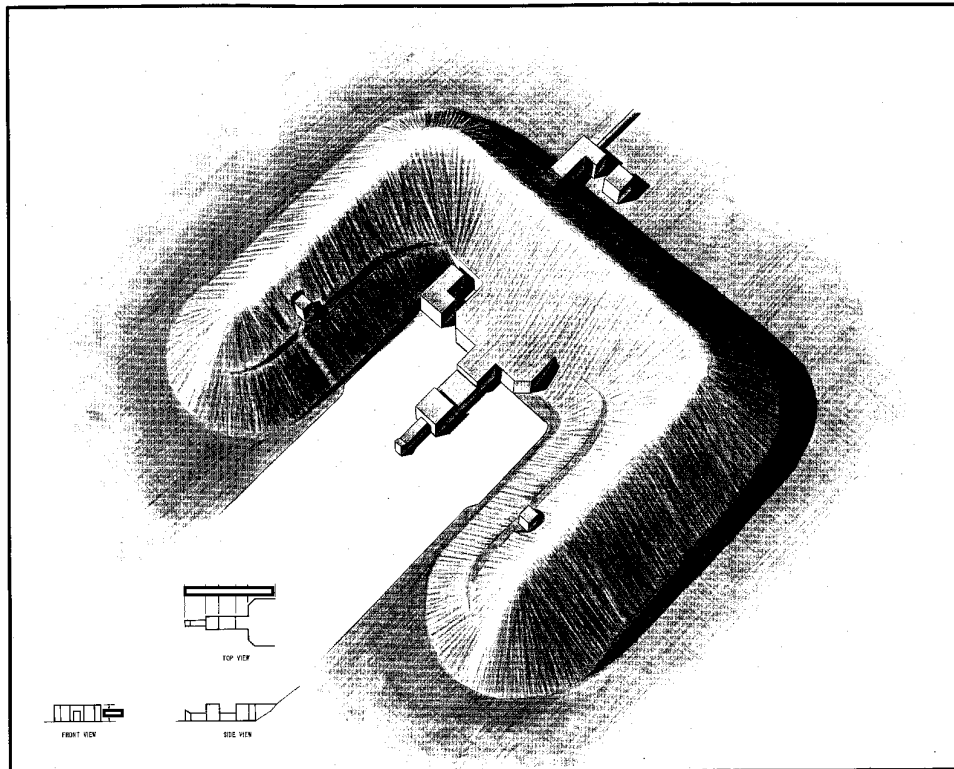
FIGURE 9. CONCEPT OF TEST POSITION 3, TEST FACILITY No. 3

All five of these positions originally contained a pair of small rectangular buildings directly opposite each other along the parallel sides of the revetment. However, Positions 1 and 3 have since been modified by the removal of both of these buildings and Position 5 by the removal of one. It is possible that these buildings are portable and can be replaced on short notice.

The rocket motor tie-down area for each pad originally appeared as a dark rectangular area aligned with the thrust block on the projecting end of a T-shaped building at the rear of the pad. At Position 3, however, an enclosed irregularly shaped structure, tentatively identified as a possible altitude simulation device, was later installed at the tie-down position. (Figure 9 shows Test Position 3 and the configuration of this device as it appears on the large-scale but non-sterco photography of [redacted]. This concept is subject to considerable change when better photography is available.) Other changes to the basic configuration of the five positions include a small probable camera station in the northeast corner of the pad at Positions 1, 4, and 5 and small over-looking camera or observation buildings on the sides of the barricade walls at Position 3.
